**Date:** 1 October 2015

DMS 0054-8182

**Re:** Risk relating to the use of service lifts

**Affected turbines:** All turbines / towers with service lifts equipped with Tractel Blocstop™ fall arrest device

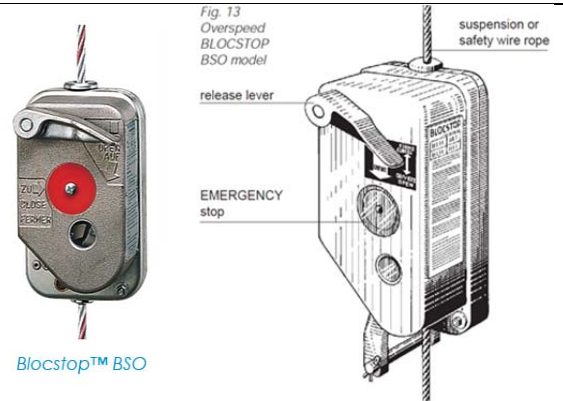
The Blocstop™ system has two functions - one is to manually brake the hoist, the other is to automatically stop the hoist in case of overspeed. The defect found prevents the correct functionality of the overspeed guard.

We have received information that a Tractel Blocstop™ fall arrest device, type BSO, has been found defective in a service lift. The defect was detected in connection with the full disassembly of the Tractel Blocstop™ unit. The defect was hidden and thus not detected in connection with the normal inspection.

**Do NOT use service lifts with Tractel Blocstop™ type BSO fall arrest device as they can have a hidden defect.**

- **Until further notice service lifts with Tractel Blocstop™ type BSO fall arrest device cannot be used.**
- **Avanti service lifts type Dolphin with Tractel Blocstop™ type OSL/ASL fall arrest devices can be used provided that prior to the first use after the release of this Safety Alert the devices are inspected according to Vestas' instructions and a pull test has been performed as specified by Avanti.**
